CARNEGIE SVRA WET WEATHER CLOSURE POLICY

A new wet weather closure policy has been established at Carnegie SVRA for the winter of 2012/13 to ensure public safety and protect water quality.

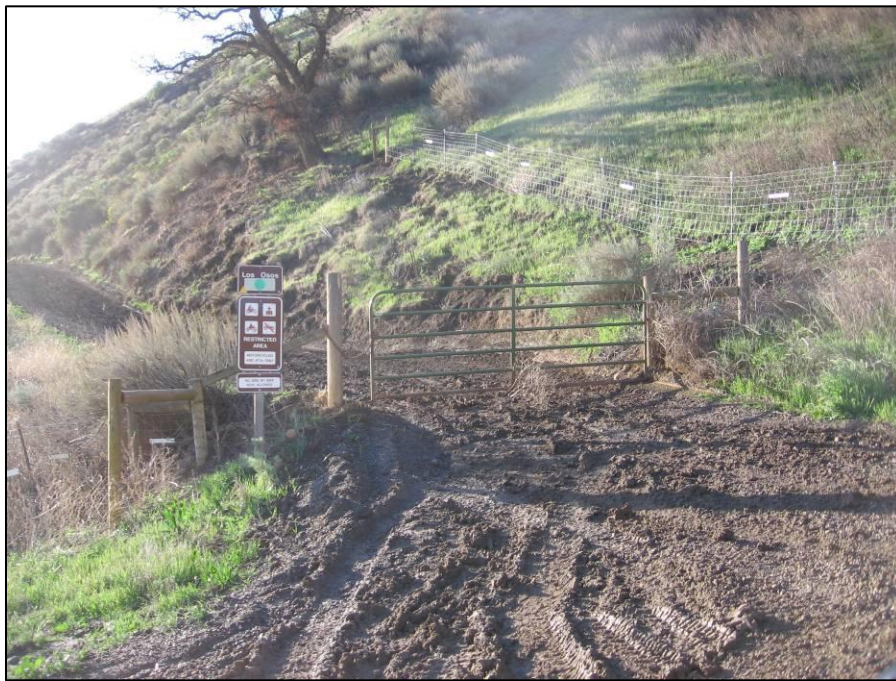
Figure 1. Example of significant rutting and unstable conditions.
The indentations were created by a typical emergency response vehicle.

- Site conditions are safe
- No environmental or resource concerns exist
- Storm water best management practices (BMPs) are functional and in good condition, such as rolling dips and basins
- The hills have been closed for at least 12 hours
- The hill slopes have dried sufficiently and soils are stable enough to support OHV use. This will be determined at the monitoring locations and hill areas using the following criteria: presence of surface water, excessive soil rutting by vehicles, BMP damage, and insufficient traction for support vehicles (see Figures 1-6 below)

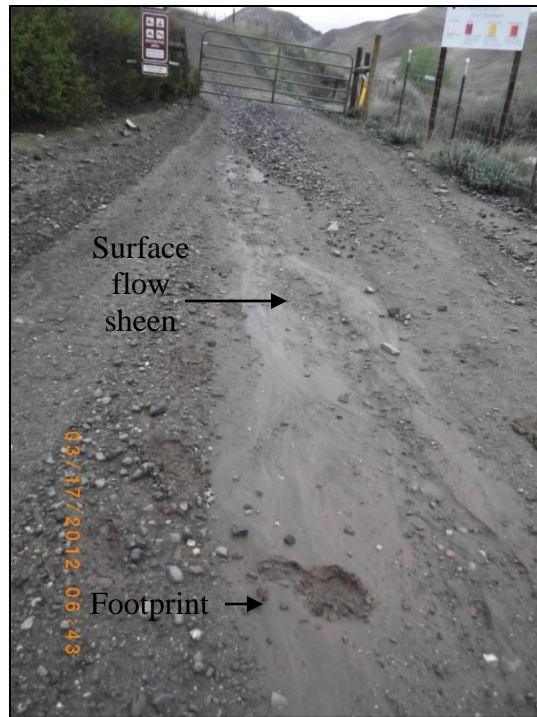
Figure 2. Unstable site conditions. The impression of the footprint and sheen of surface flow suggest the site is not dry enough to reopen.

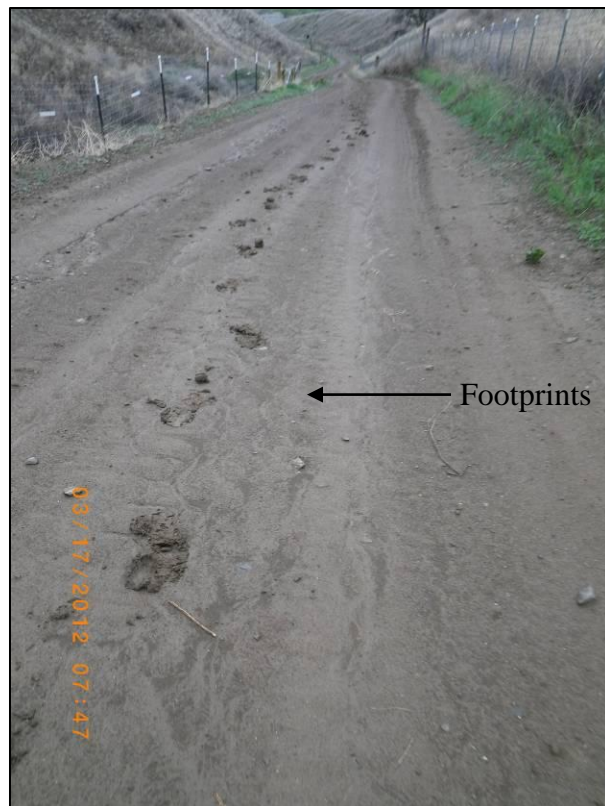
Figure 3. Example of unstable site conditions. The impression of the footprints suggest the site is not dry enough to reopen.

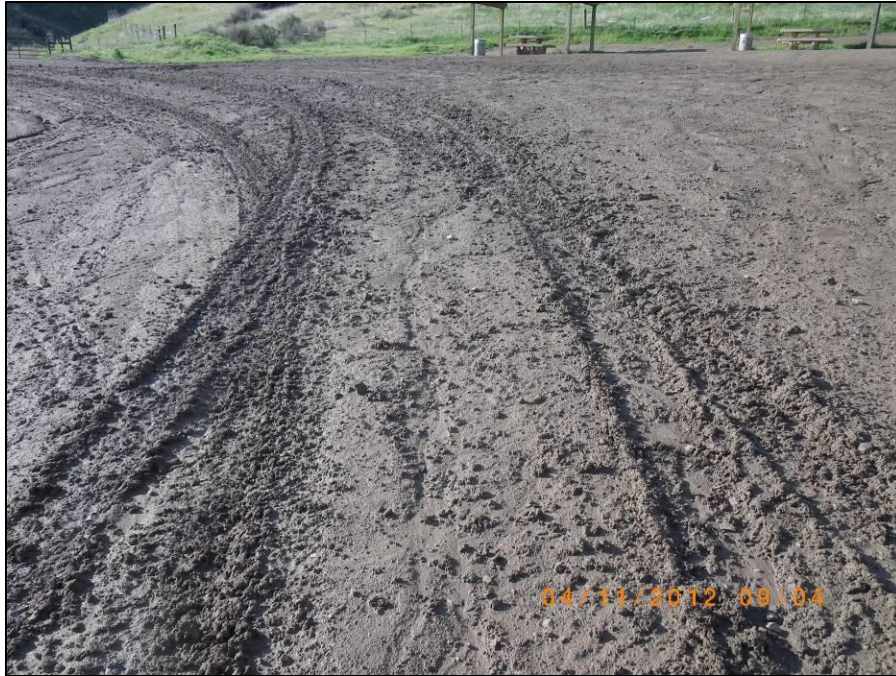
Figure 4. Example of significant rutting and unstable conditions.
The indentations were created by a typical emergency response vehicle.

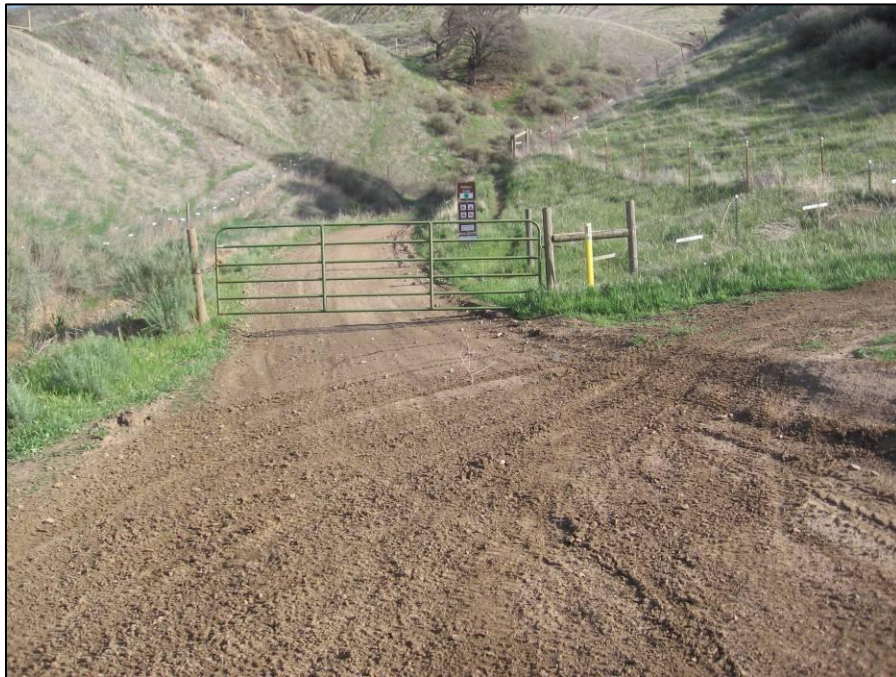
Figure 5. Example of stable conditions.
Recent vehicular activity in the foreground show minimal signs of rutting.

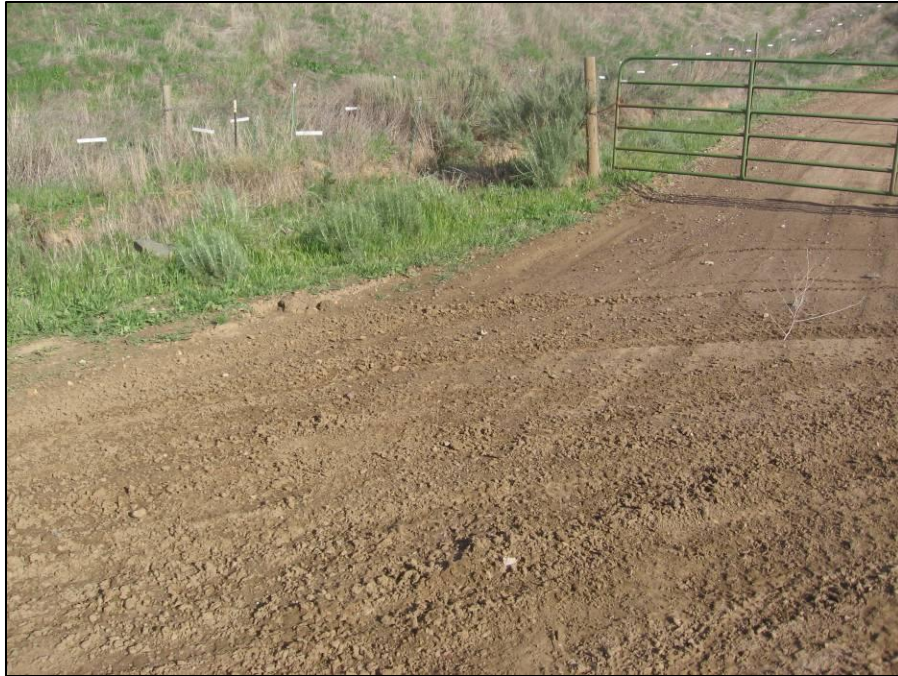
Figure 6: Example of stable conditions. Recent vehicular activity in the foreground show minimal signs of rutting.
